VERIFICATION REQUIREMENTS FOR COVER SYSTEMS

Technical Guidance for
Developers,
Landowners and
Consultants

Yorkshire and Humberside
Pollution Advisory Council

Version 3.1 – October 2014

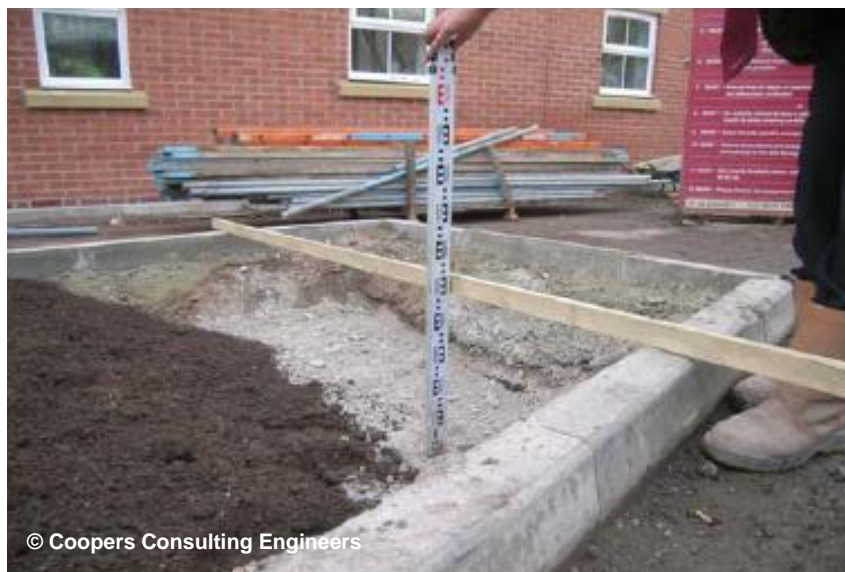
Photograph 1: Depth check of inert cover within area of public open space. Physical break layer and topsoil visible.

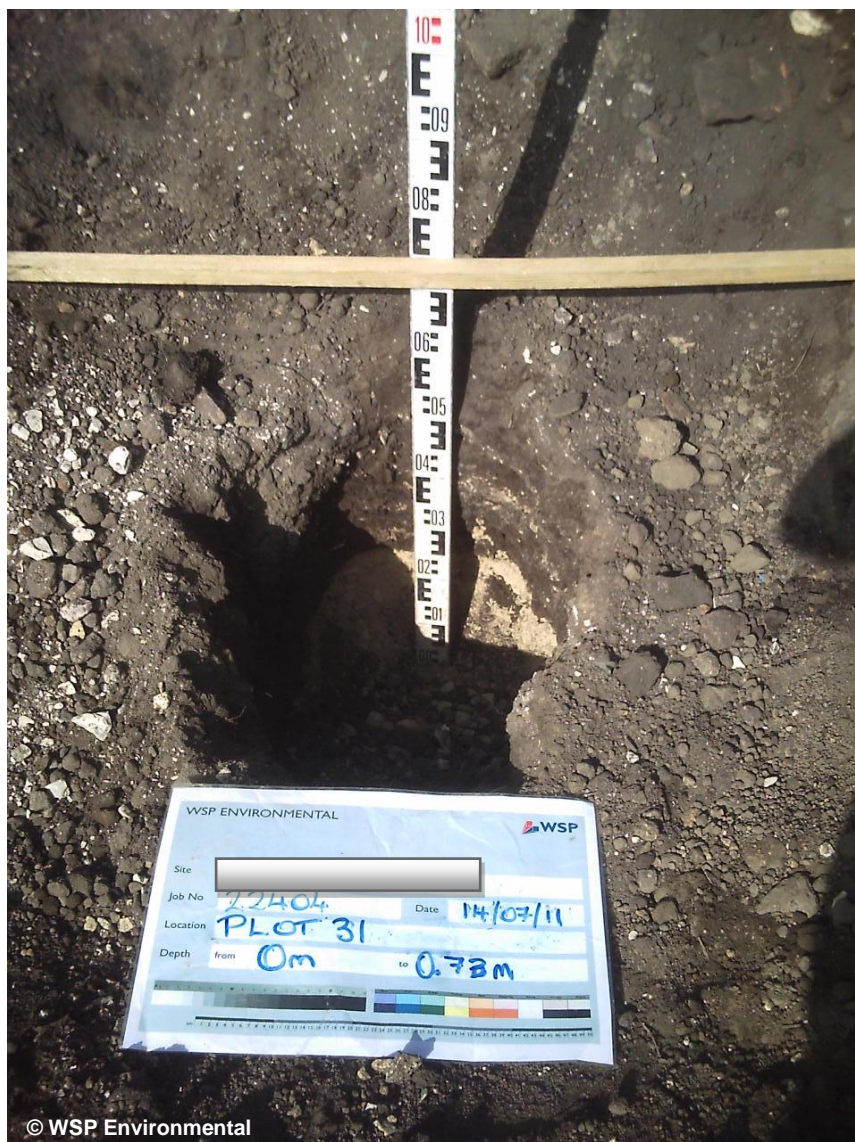
Photograph 2: Depth check of inert cover with Site & Location Information Board.

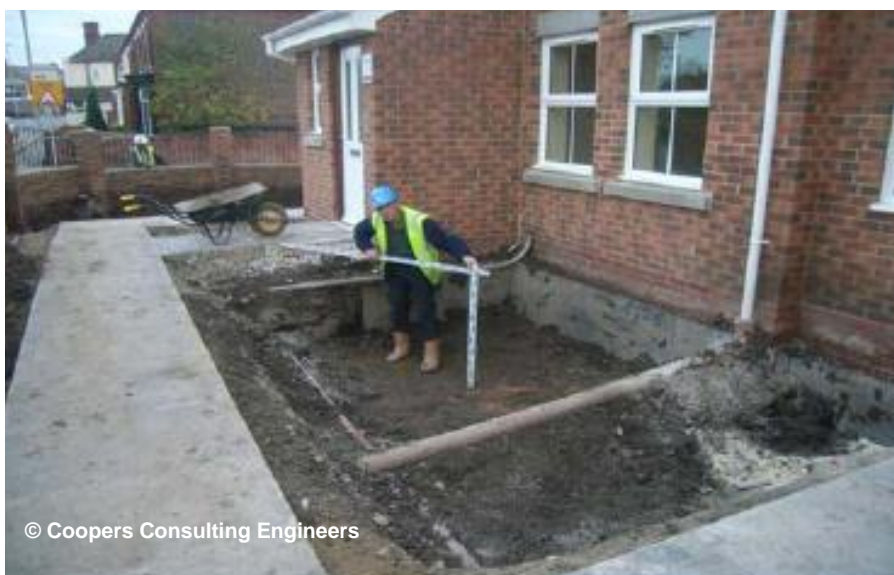
Photographs 3 & 4:
Depth check of inert
cover within areas of
front gardens.

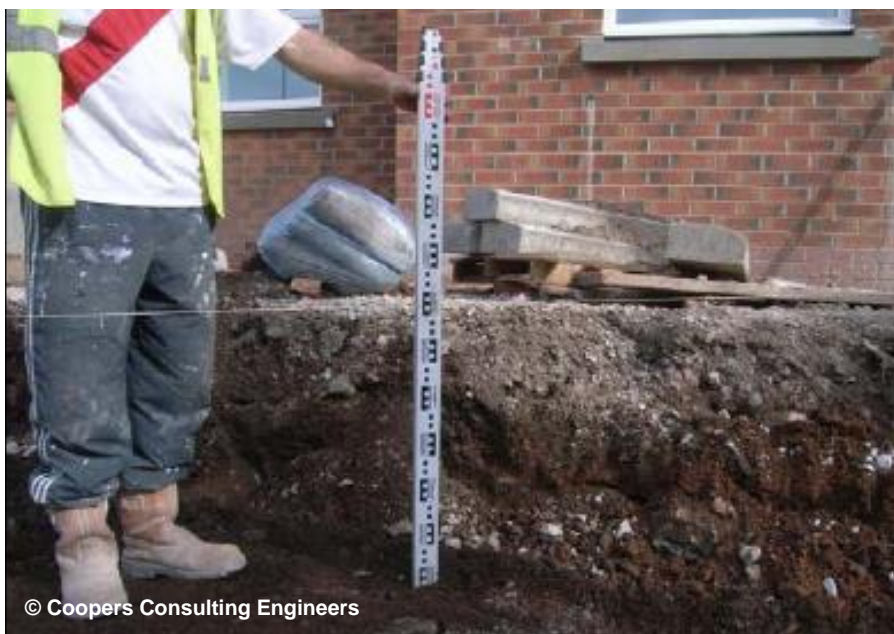
Photographs 5 and 6: Depth check of inert cover within rear gardens. Taut string line spans across excavation.

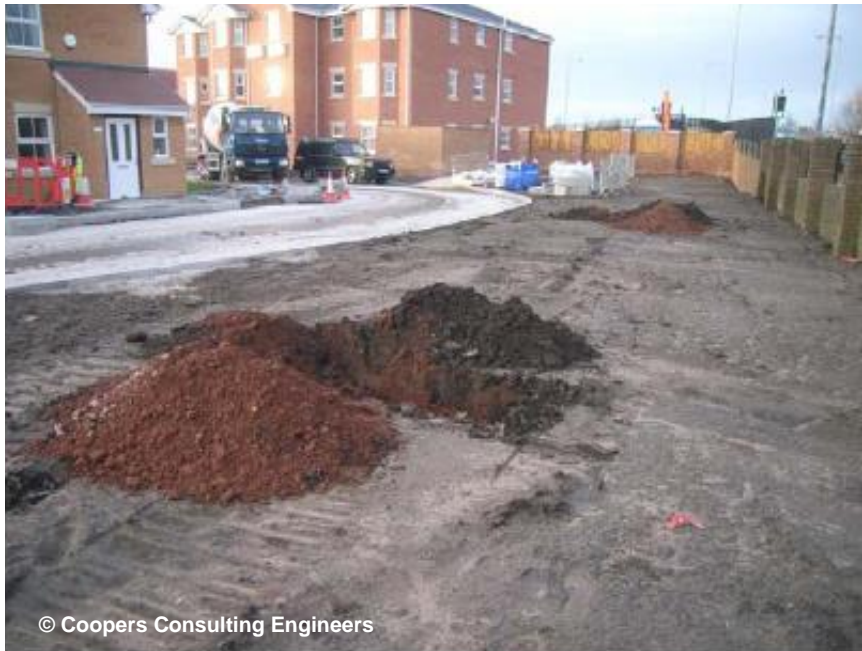
Photograph 7 shows the spatial location of the verification pit.

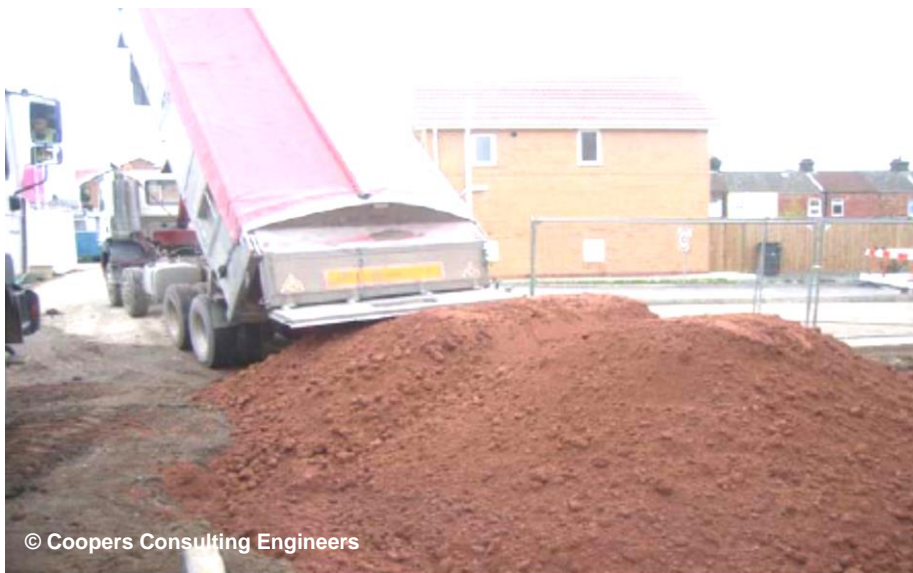
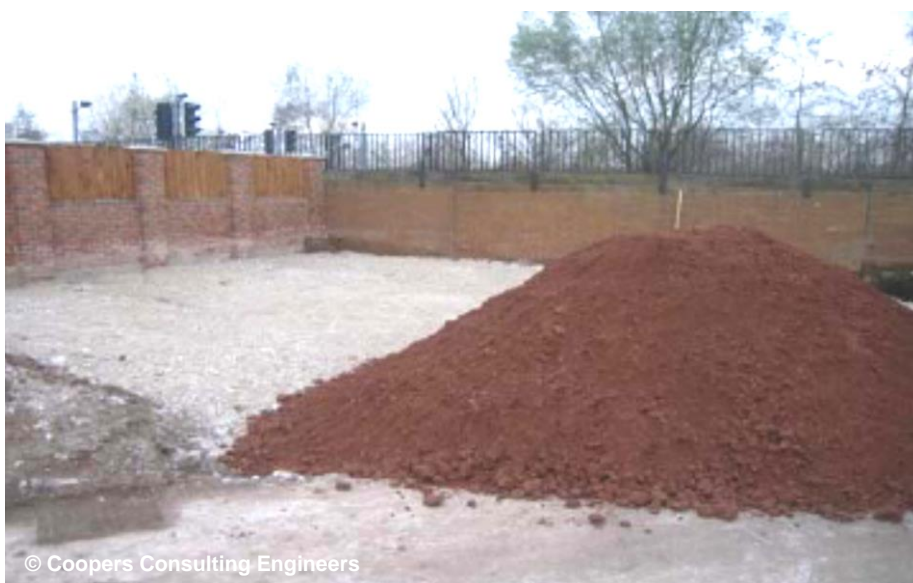
Photographs 9 and 10: Inert crushed sandstone being delivered with remediation break layer visible in Photograph 10. The spatial area of the remediation can be observed from these photographs (old terrace housing in Photograph 9 and traffic lights in photograph 10).

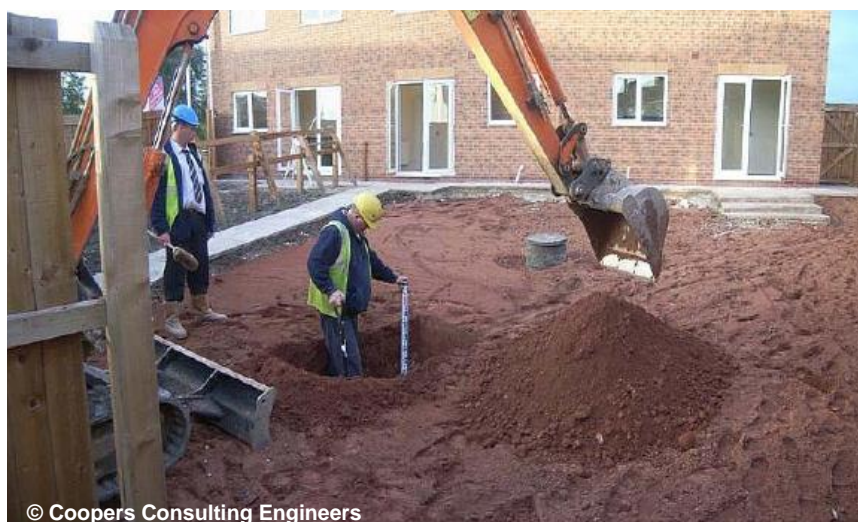
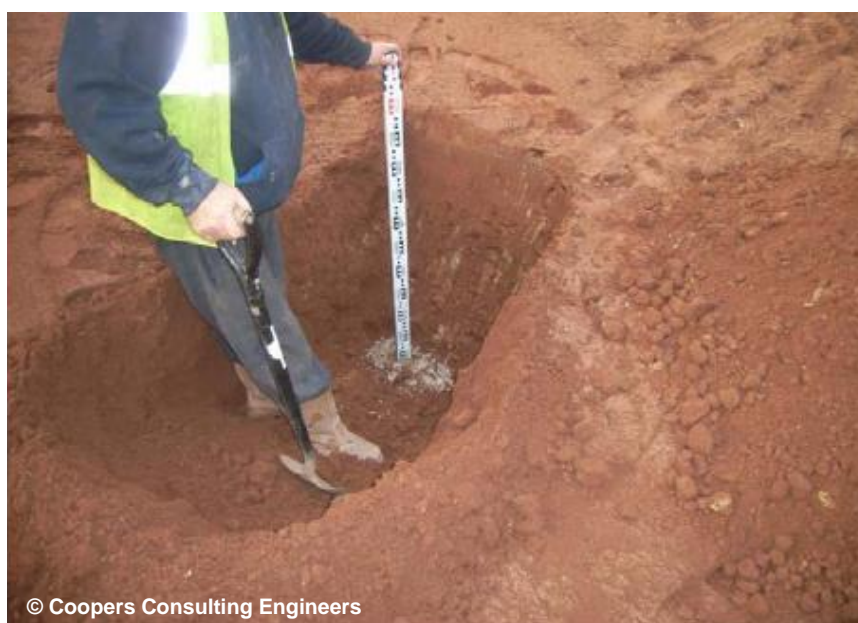
Photographs 11 and 12 show the remediation of the rear garden, with a significant depth (1.0m) of inert cover. Remediation break layer visible at the base of the excavation. Photograph 11 has been stitched to form a panoramic photograph and hence there is slight distortion
